STATE OF CALIFORNIA
 CALIFORNIA NATURAL RESOURCES AGENCY
 DEPARTMENT OF WATER RESOURCES
 DIVISION OF SAFETY OF DAMS

INSPECTION OF DAM AND RESERVOIR IN CERTIFIED STATUS

Name of Dam Murphys Wastewater Dam No. 2024 County Calaveras
 Type of Dam Earth Type of Spillway Drop Inlet/Culvert/Open Channel
 Water is ~15 feet below spillway crest and ~19 feet below dam crest.

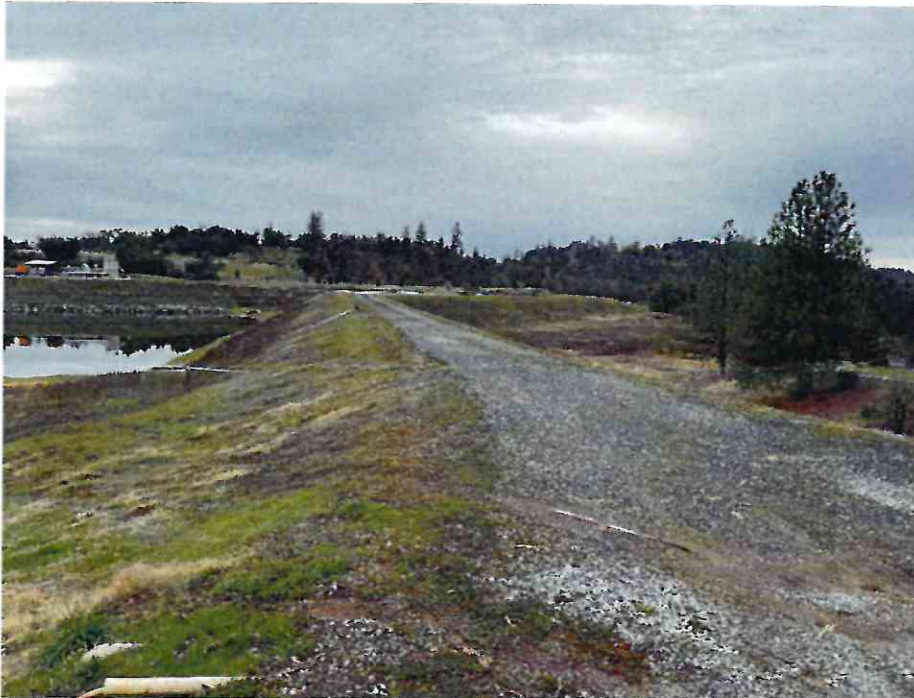
Photo 1: View of the crest and upstream face of the West Dike from the right abutment.

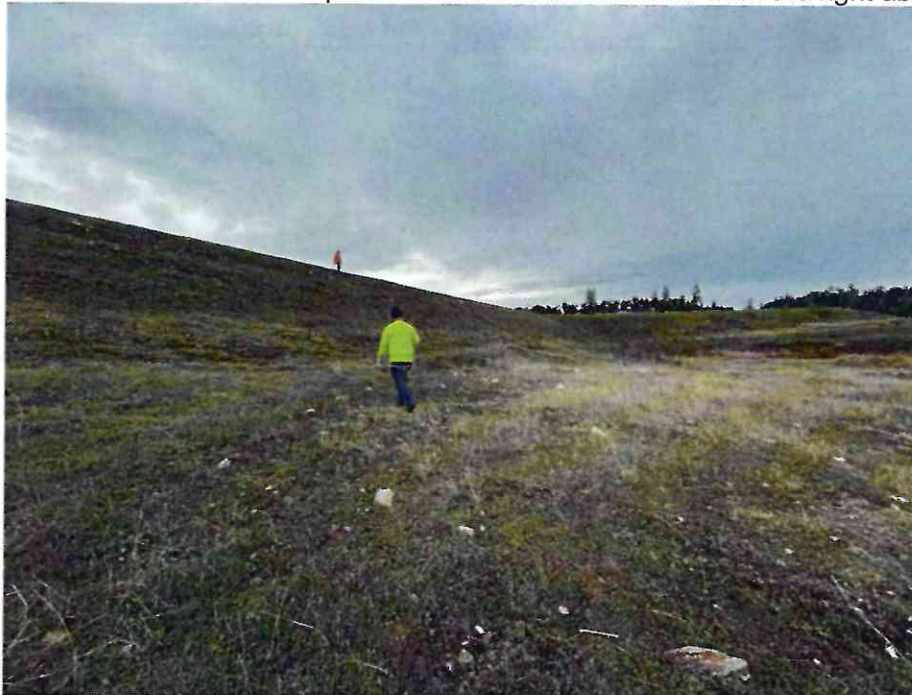
Photo 2: View of the downstream face of the West Dike from the right abutment.

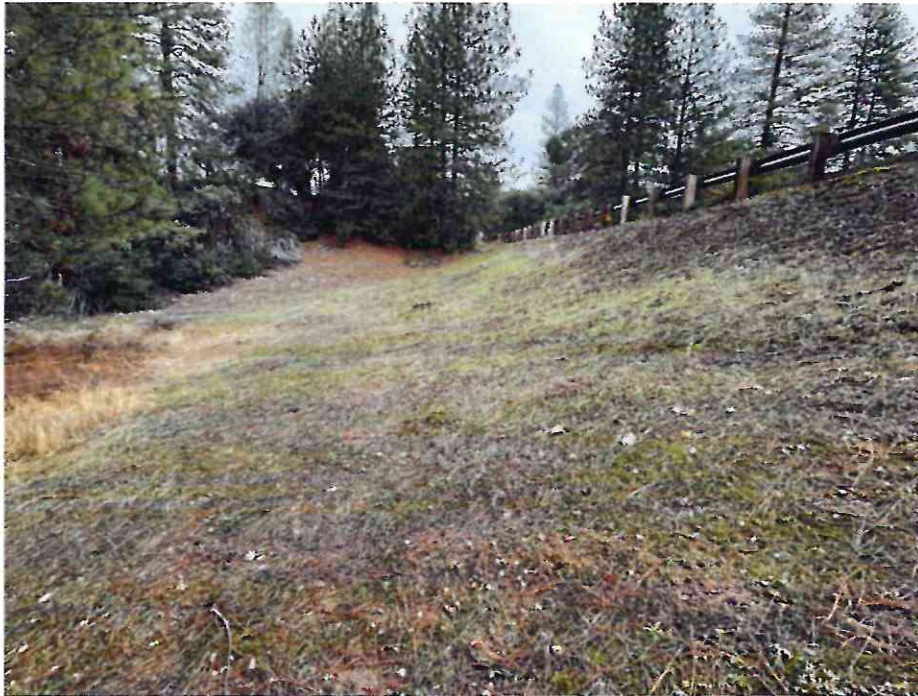
Photo 5: View of the downstream face of the Main Dam.

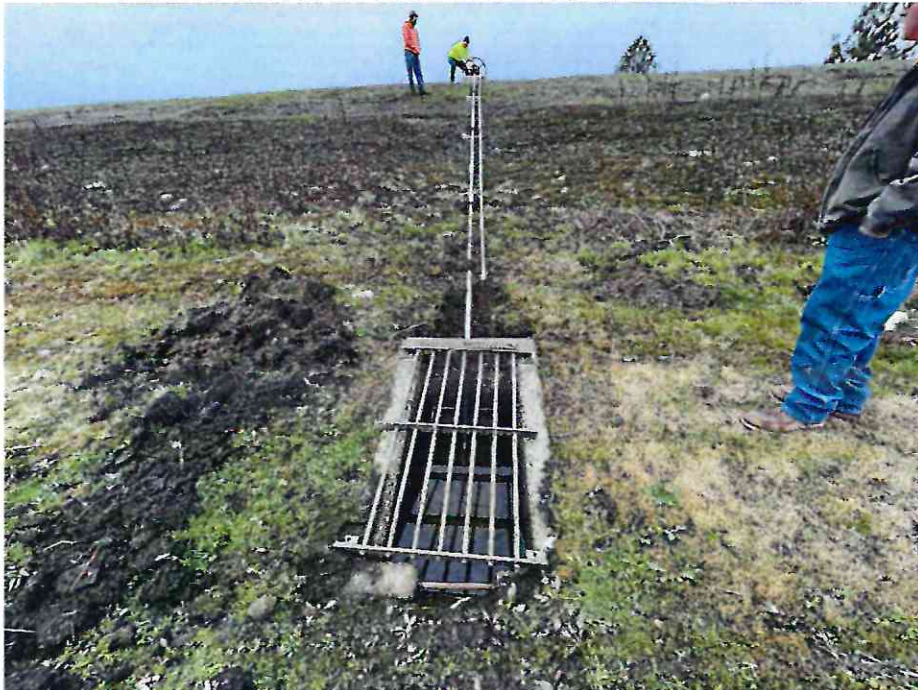
Photo 6: View of the upstream slide gate inlet looking downstream.

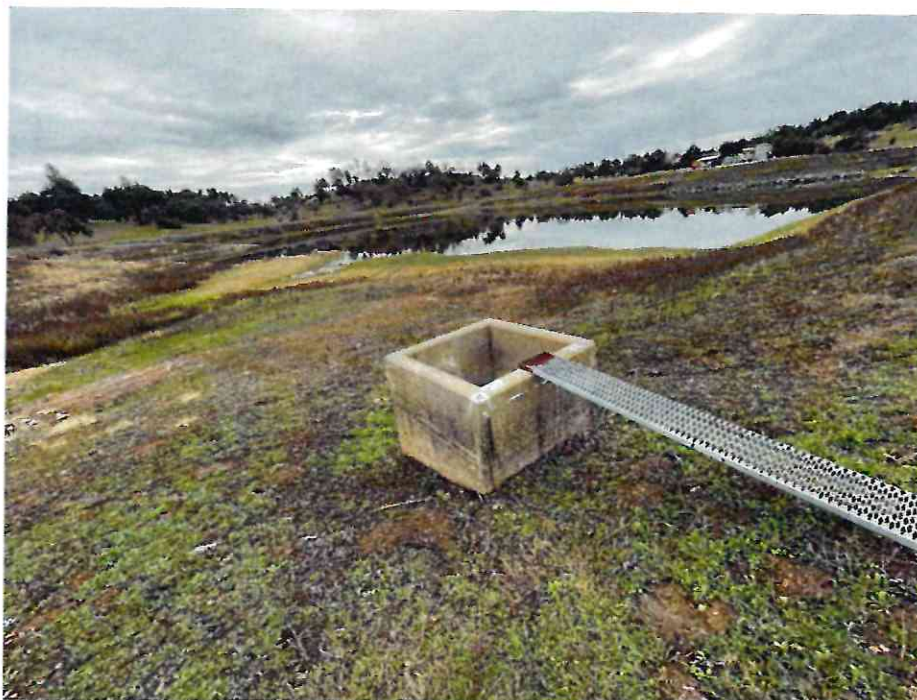
Photo 7: View of the spillway approach and drop inlet.

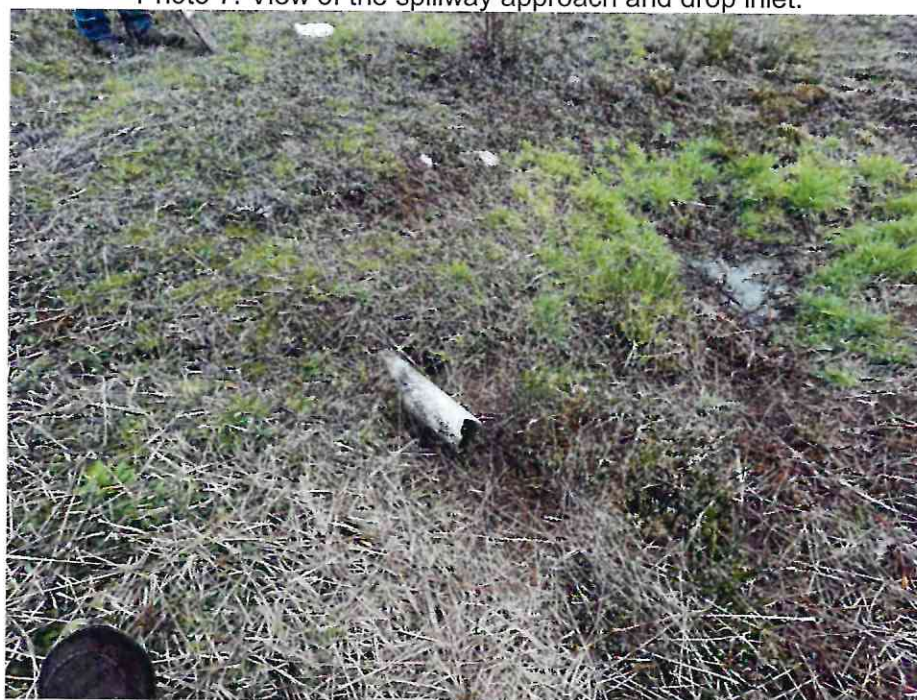
<u>Seepage</u>	The downstream faces, groins, and toes of the dams appeared dry during this inspection. Two of the three drainpipes were observed during this inspection. No flow was observed in the two drainpipes. All three drainpipes need to be observed during the next inspection. As noted in the previous inspection reports, a future inspection needs to provide a picture of the right drainpipe to document its location at the dam. A photo of the drainpipe was not taken during this inspection. The seepage conditions are consistent with past observations under similar reservoir levels.
<u>Instr.</u>	There is no instrumentation at this dam, and none is deemed necessary at this time.

Photo 8: View of the left drain at the toe of the West Dike.
